Manhole Inspection Summary

Manhole # S05WW1012MH

Insp Date: **9/13/06 7:52 AM**

Location Address: **5714 WINNER AVE**

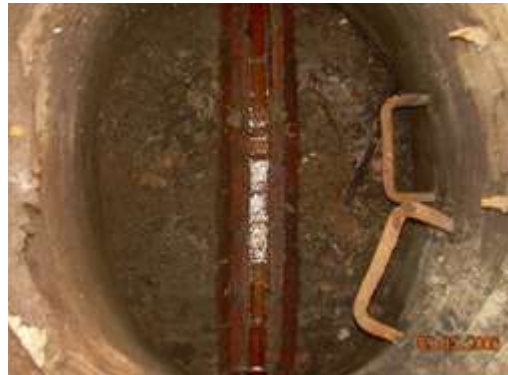
Top View

Condition: ☐ Sound ☐ Cracked ☐ Root Intrusion ☐ Loose Brick ☒ **Deteriorated**

Infiltration: ☐ None ☒ **Joint** ☐ Cracks ☐ Mortar ☐ Roots ☒ **Wall**

Steps Count: **3** Missing: **1** ☒ **Corroded**

Surcharge ☒ **Evidence Of Surcharge** Depth: **1** (ft.) ☐ Active Surcharge Present

Adjustment deterioration and infiltration. Corbel and Barrel infiltration. Evidence of surcharge - Bench debris. Corroded

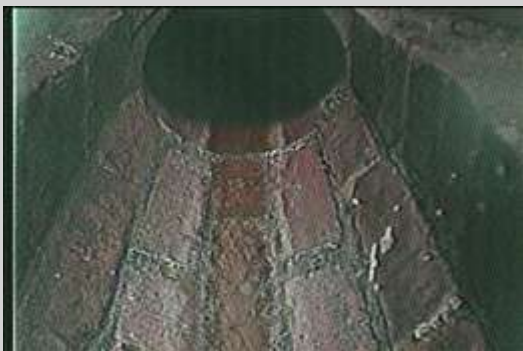
8 in. Circular Gravity Sewer Pipe In @ 6 O'Clock

Condition: ☐ Sound ☐ Cracked ☐ Root Intrusion ☒ **Deteriorated** ☐ Leaks ☐ Debris

Channel deterioration.
